Noank Elementary School Building and Site Analysis

**Prepared by
Town of Groton
Public Works Department**

July 2010

Building Condition
As of June 1, 2010

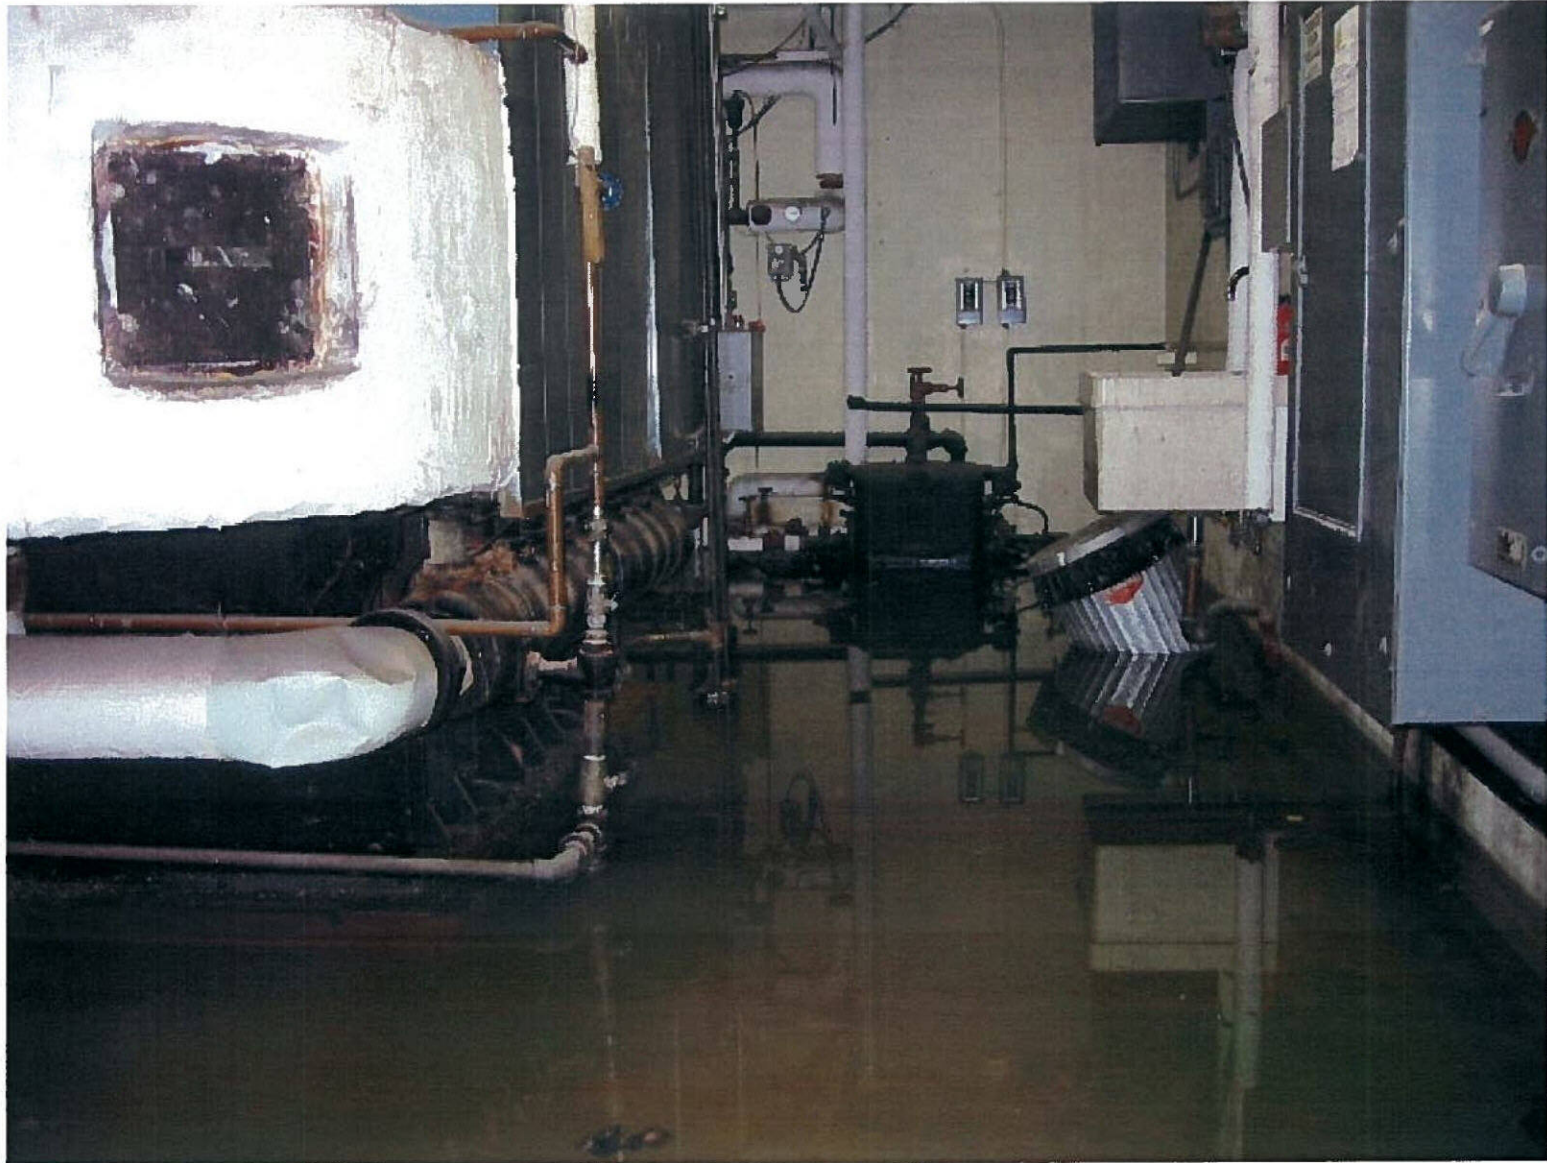
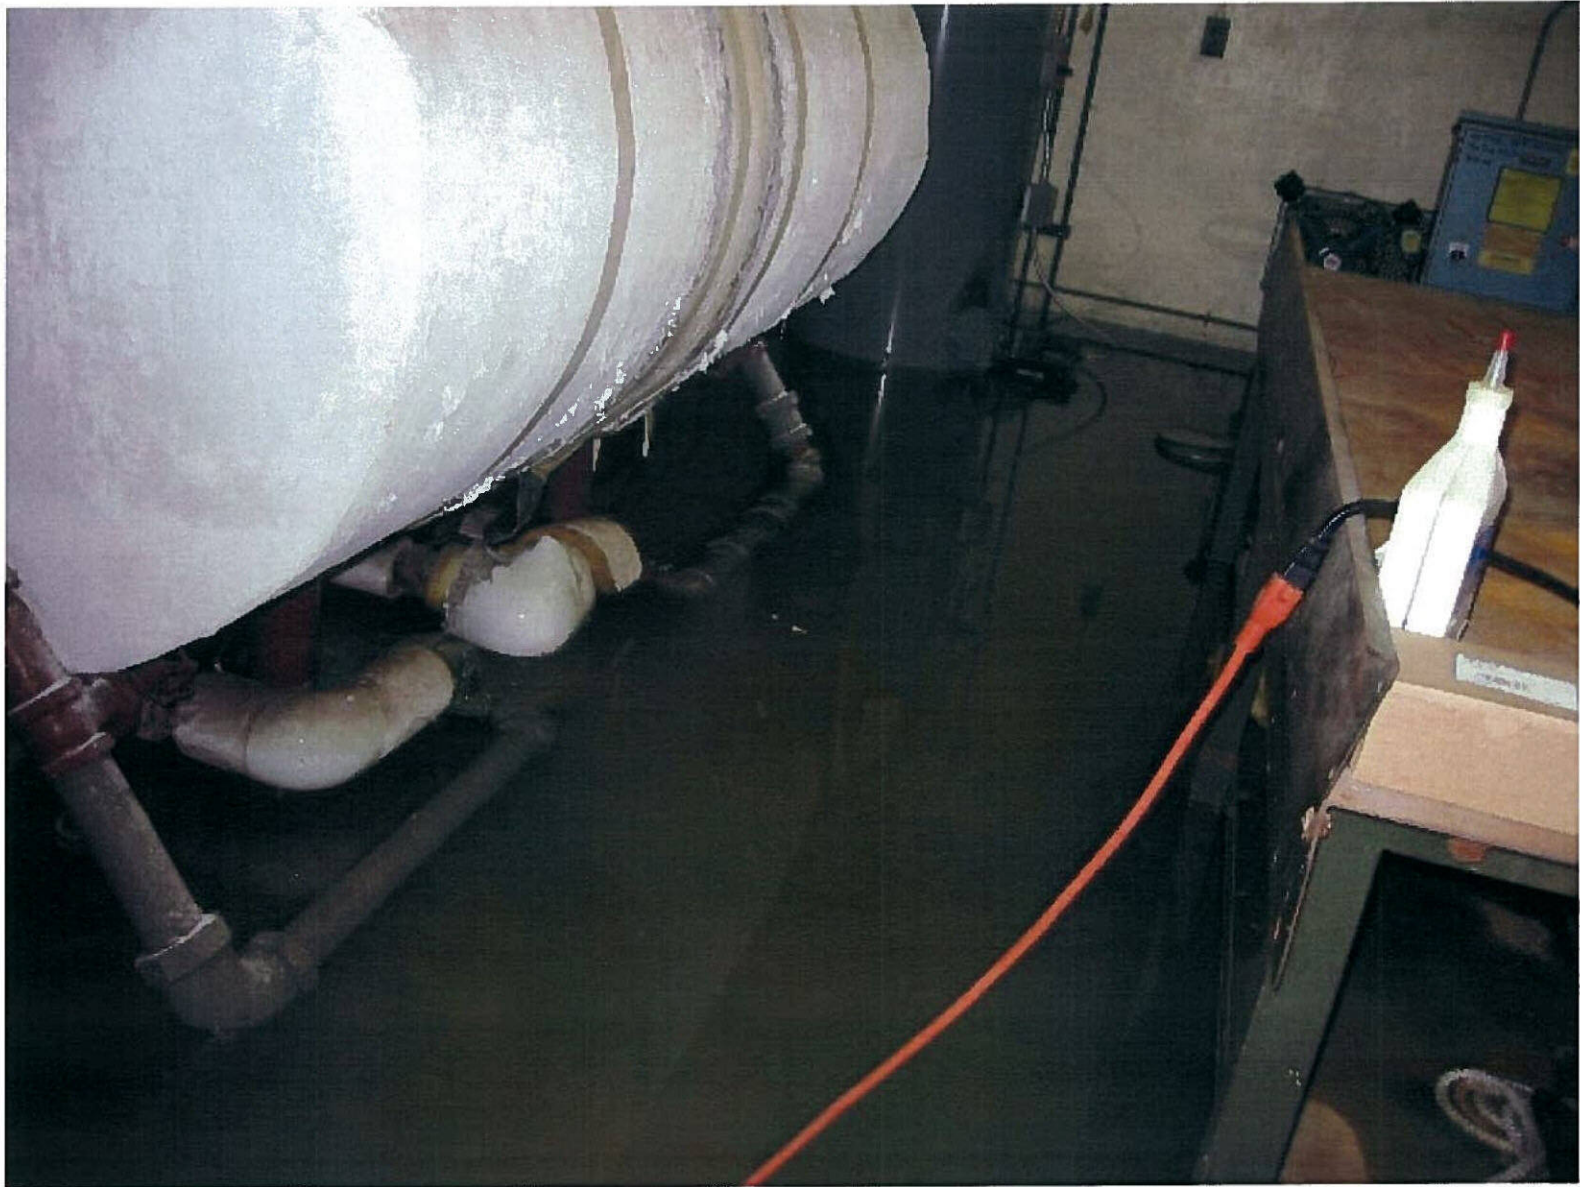
Groundwater seeps into the boiler room from beneath the school and was controlled by a sump pump. During the heavy rains of March 29 – 30, 2010, there was over a foot of water in the boiler room which destroyed the following: 2 condensate pumps, 2 circulator pumps and domestic hot water burner/motor. The estimate to repair or replace all these items is \$13,475. (See photos on pages 4 - 5 of attached briefing.)

Flooded Boiler Room

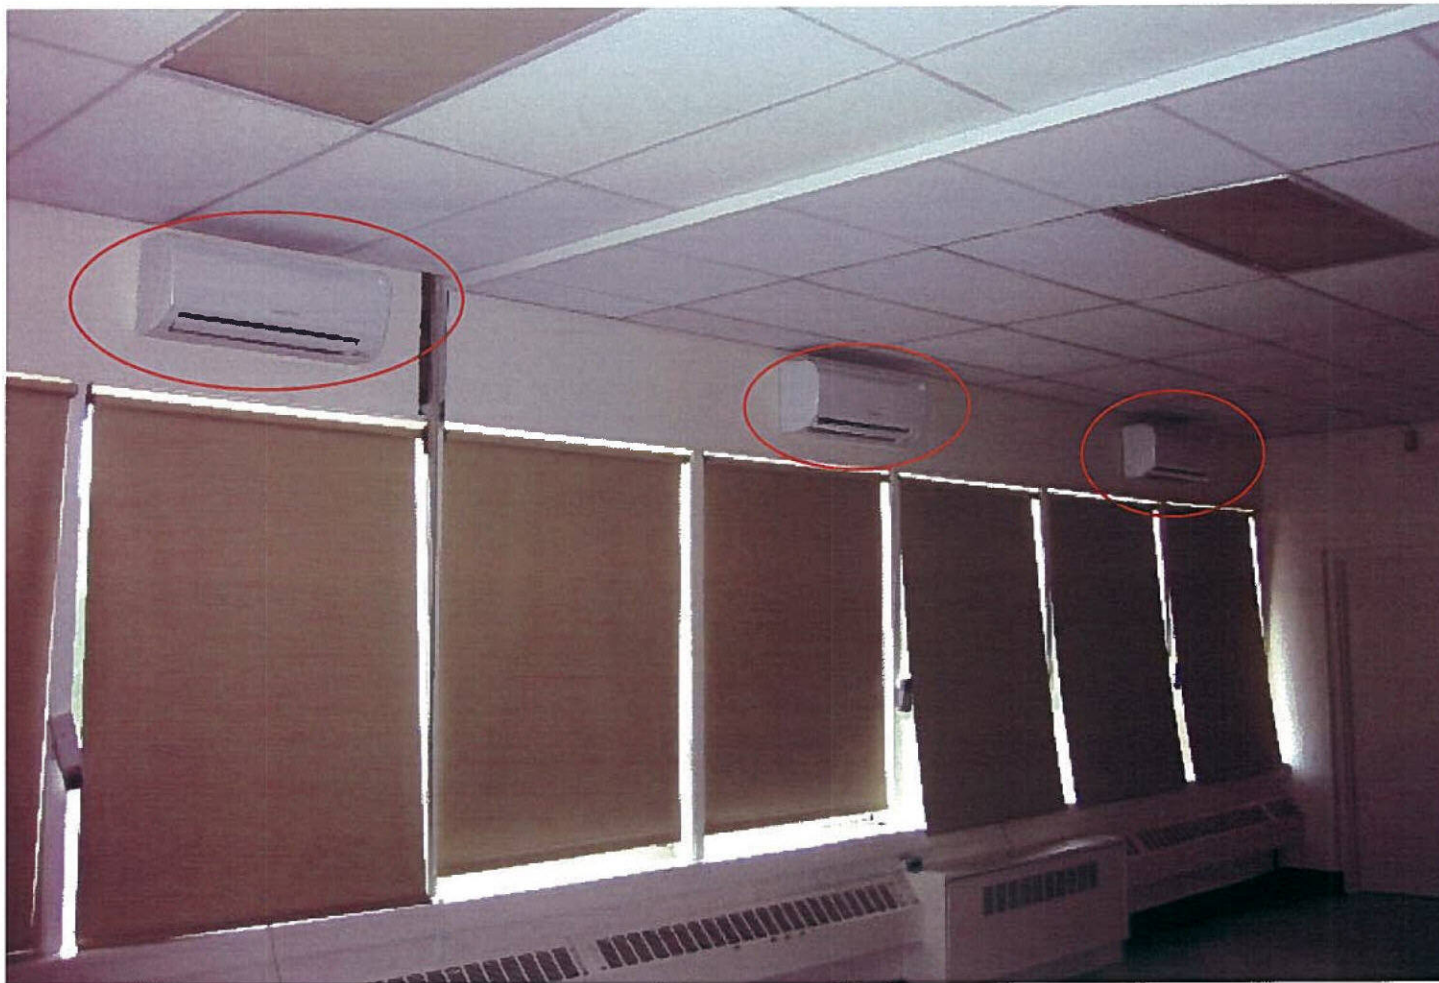
Three split system air conditioners in the classroom that was modified into a fitness room for the temporary Senior Center. Four split systems will be moving to the Town Hall to IT server room.

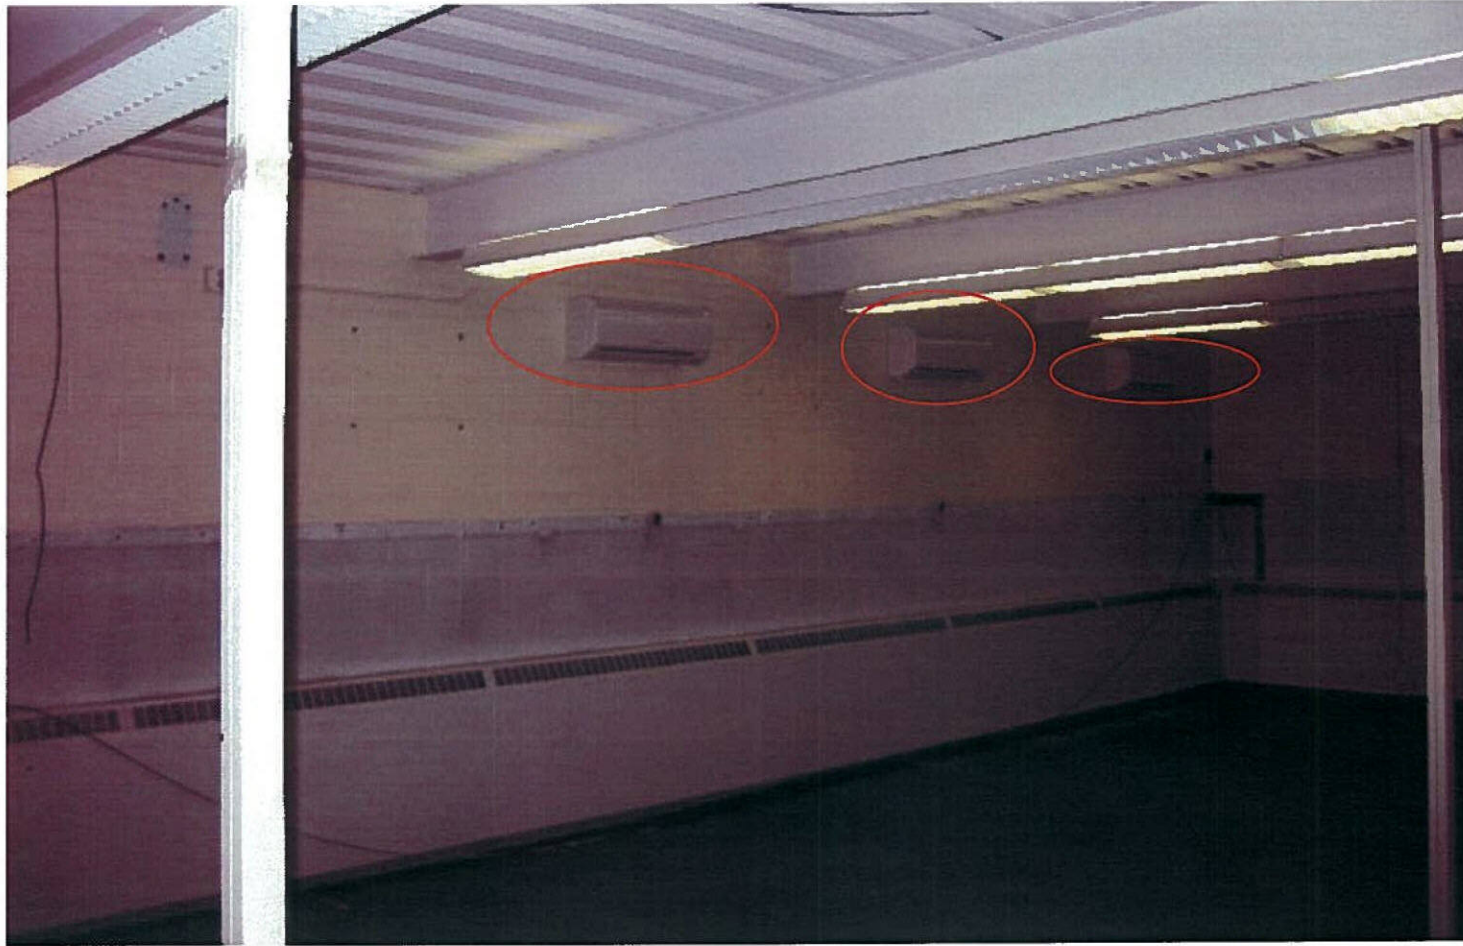
Three split system air conditioners in the old library room that was modified into the computer training room for the temporary Senior Center. Four split systems will be moving to the Town Hall to IT server room.

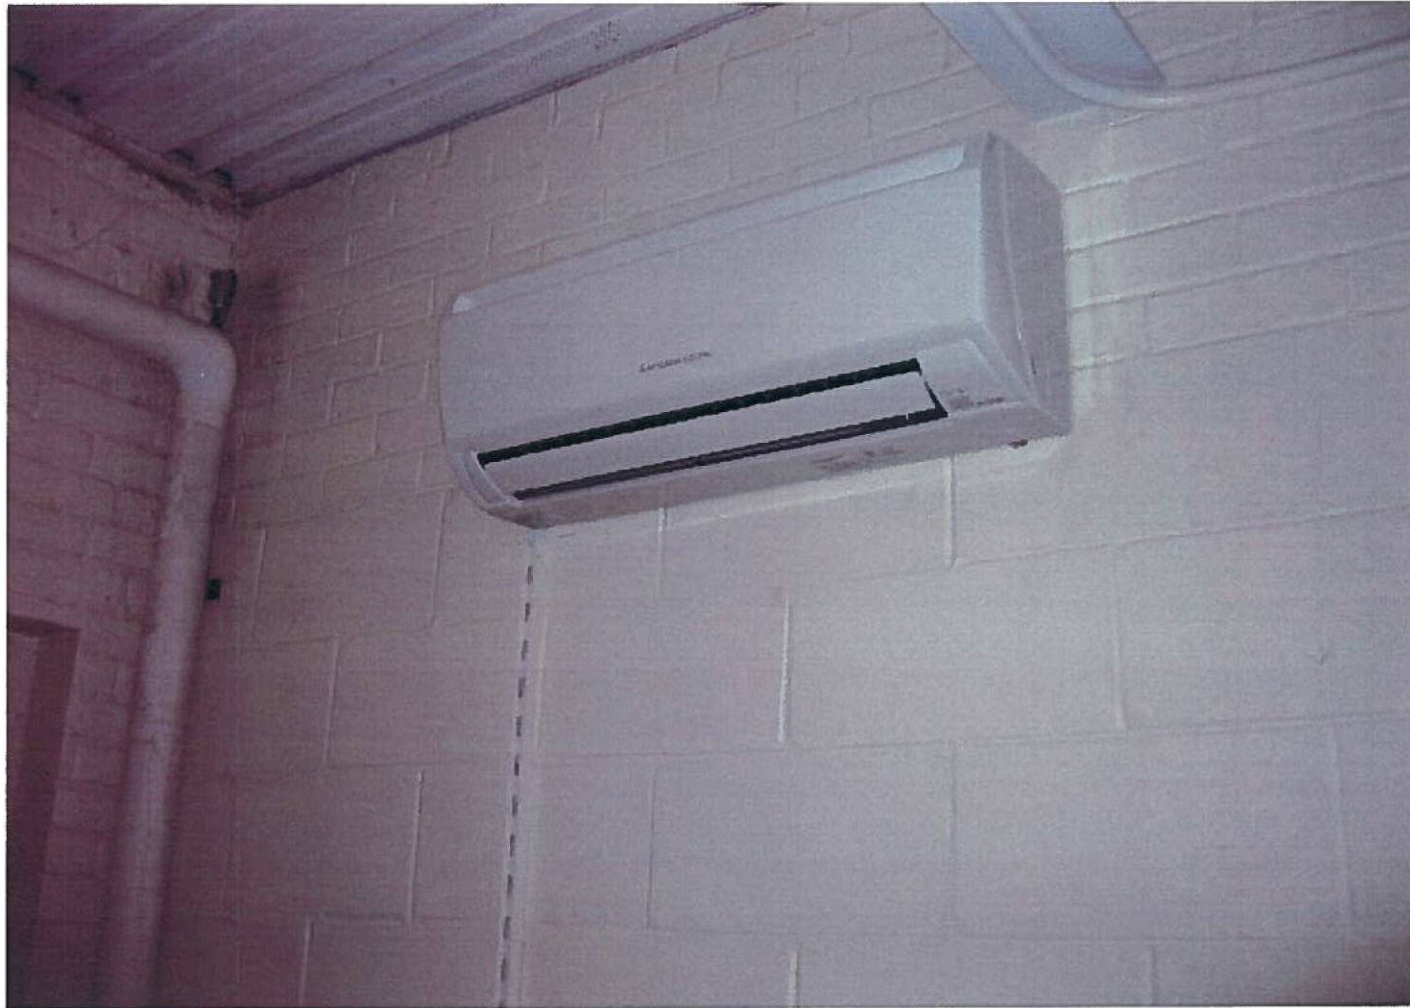
One split system air conditioners in the old Library Office that was used for the computer training for the temporary Senior Center. Two split systems will be moving to the Town Hall to IT server room.

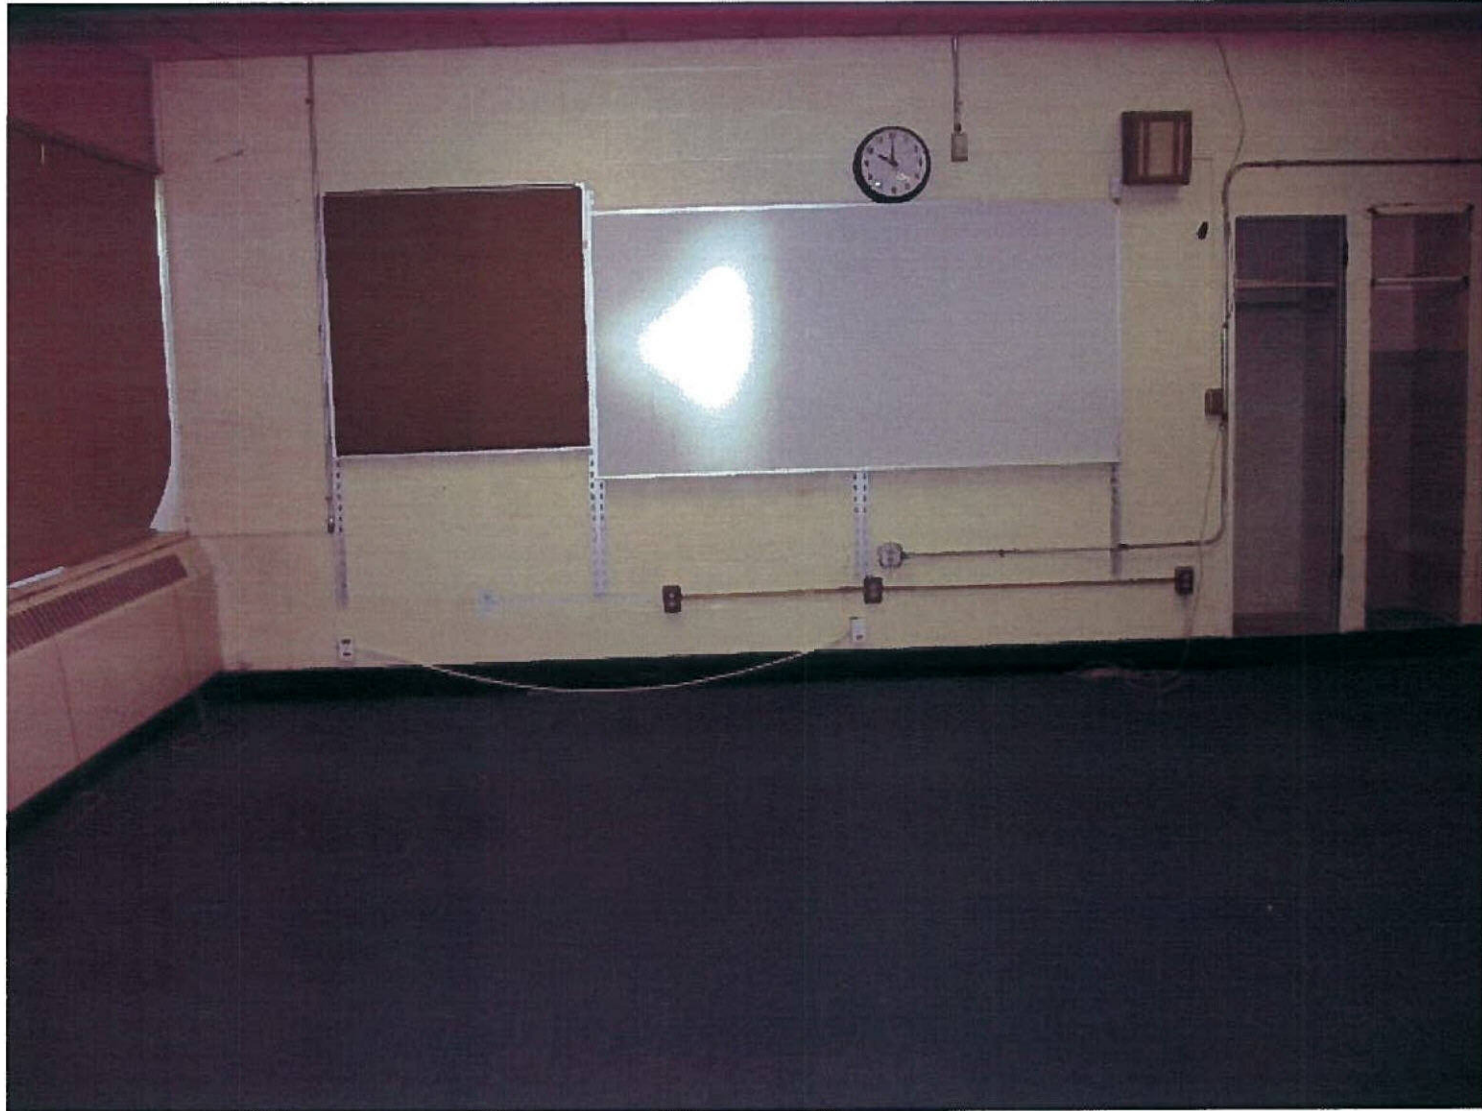
Classroom – this one is wired for computer network and cable and has at least 5 double outlets in this classroom

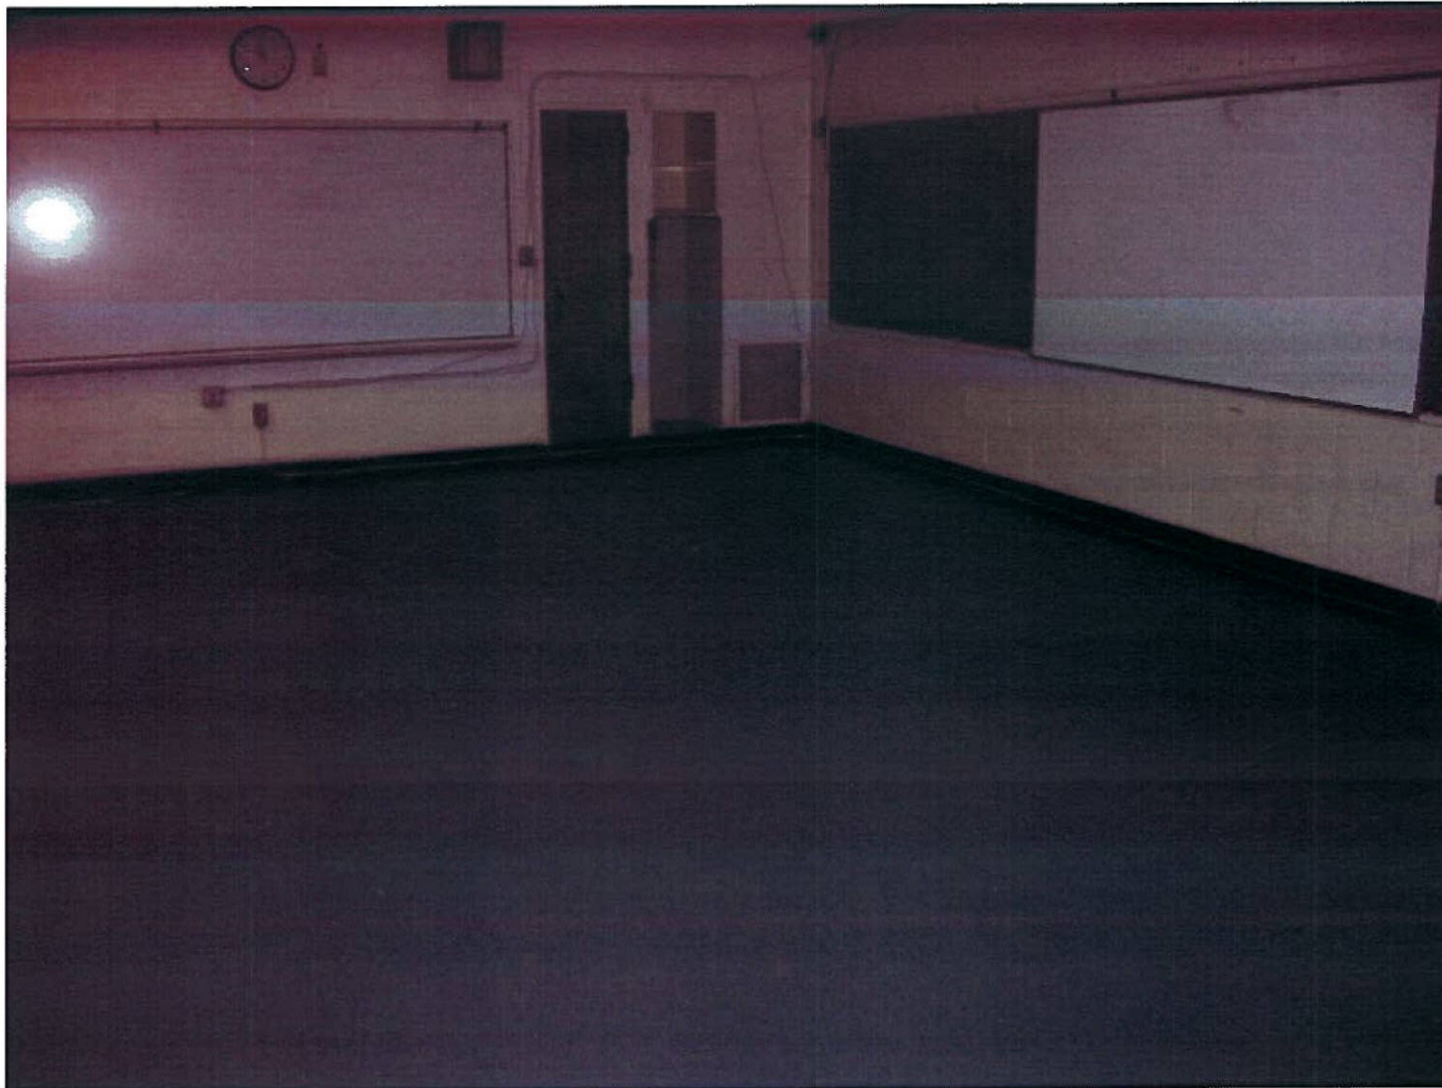
Classroom – this one is wired for cable and has at least 3 double outlets in this classroom

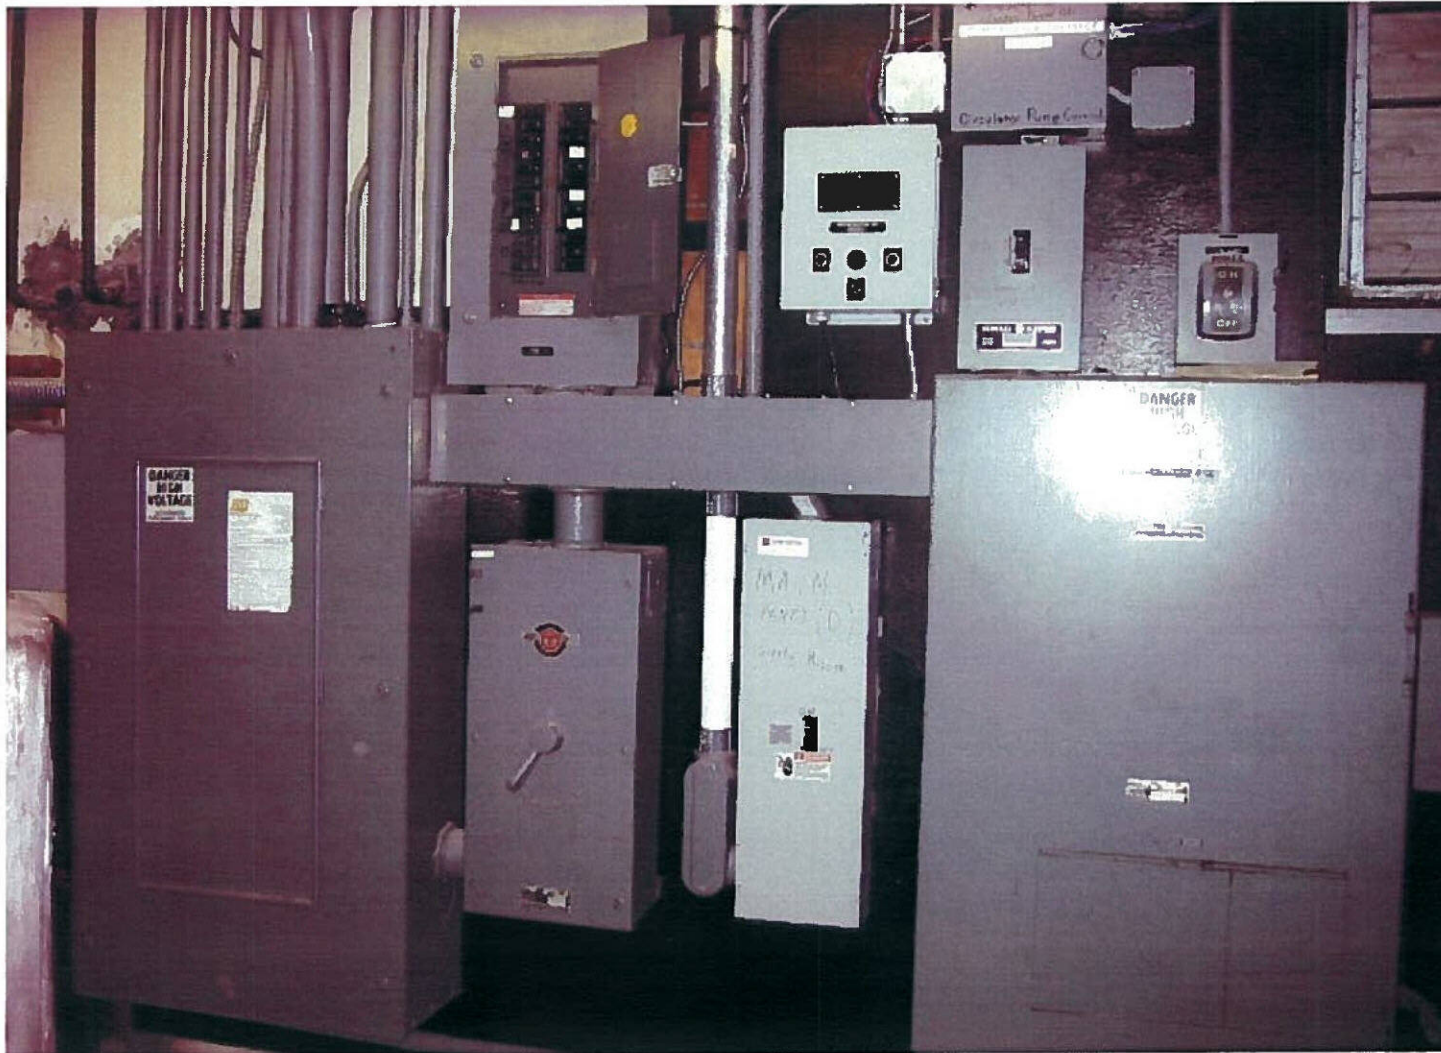
The main electrical service is fed from a pad-mounted transformer on the east side of the building. The service is 800 ampere (1000 amperes with 800 ampere main circuit breaker) at 208 volt/3-phase. (See photo 9 of attached briefing.)

The electrical service located in the mechanical room which floods with high groundwater. The service 208 volt – 3 phase.

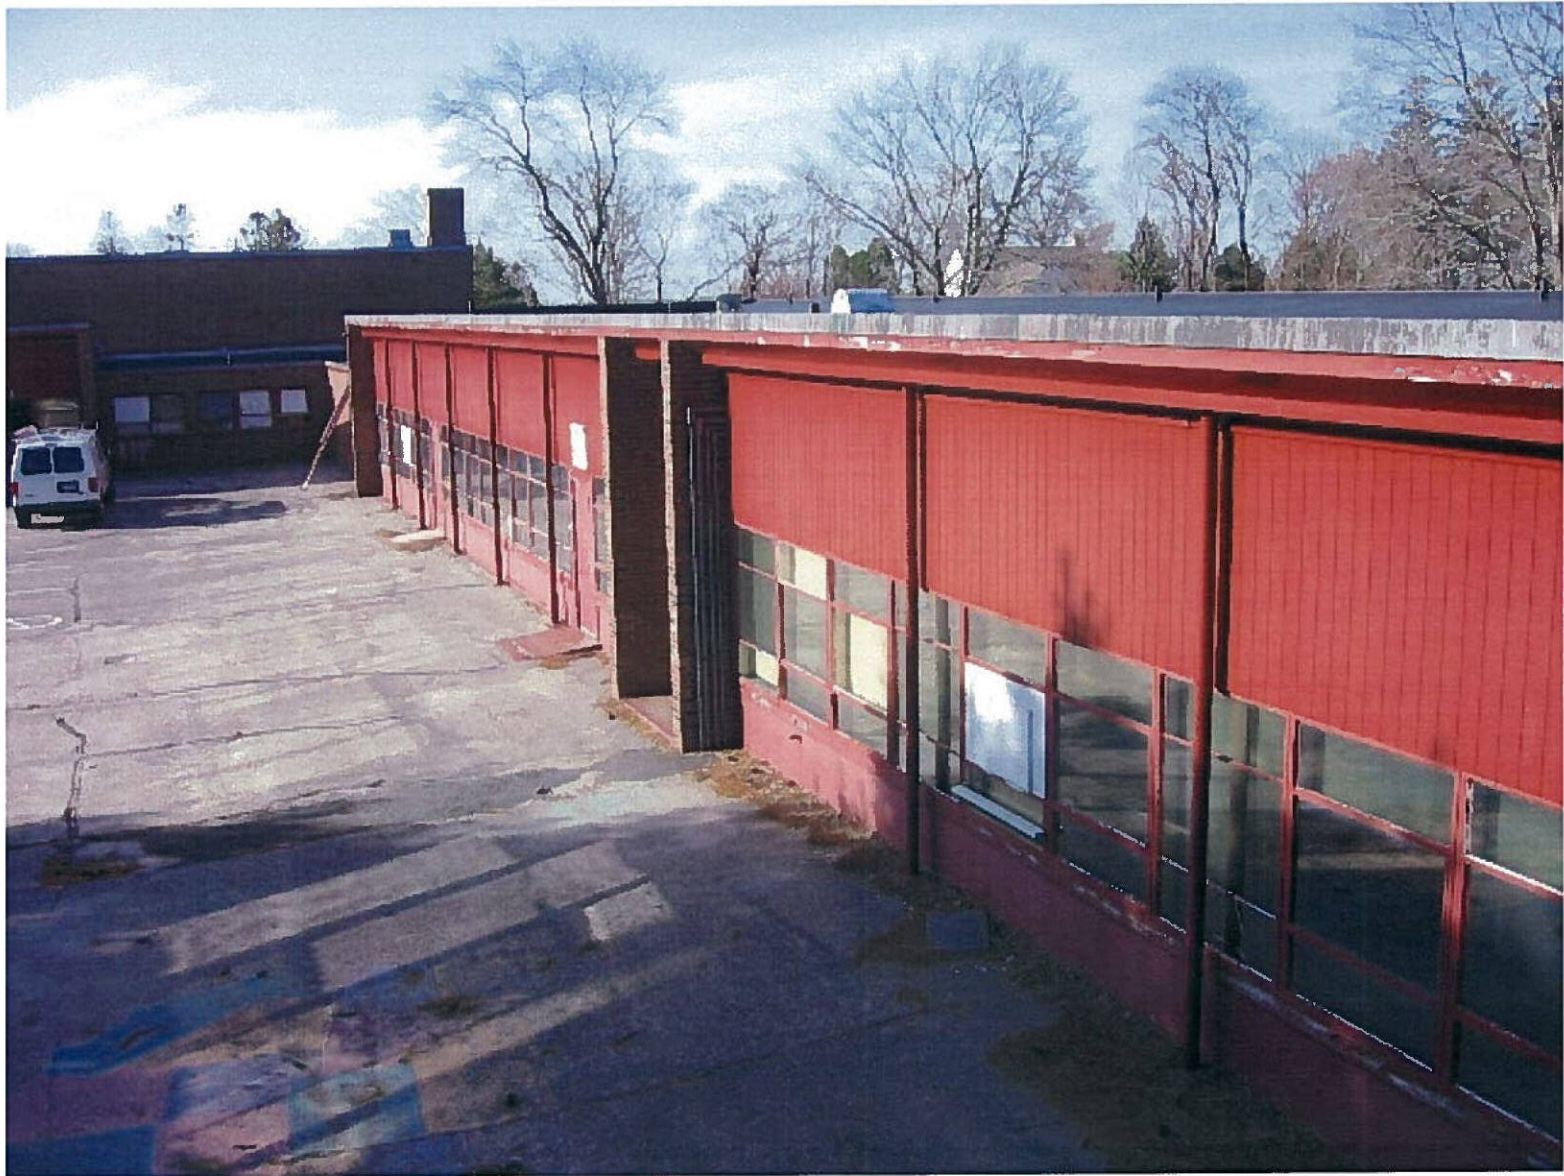
The windows (2,896 square feet) are single pane and not energy efficient or hurricane resistant.

Chipping paint – single pane windows – no central air conditioning

The estimated replacement cost with energy efficient, debris resistant windows is approximately \$125 per square foot or \$362,000 for this building.

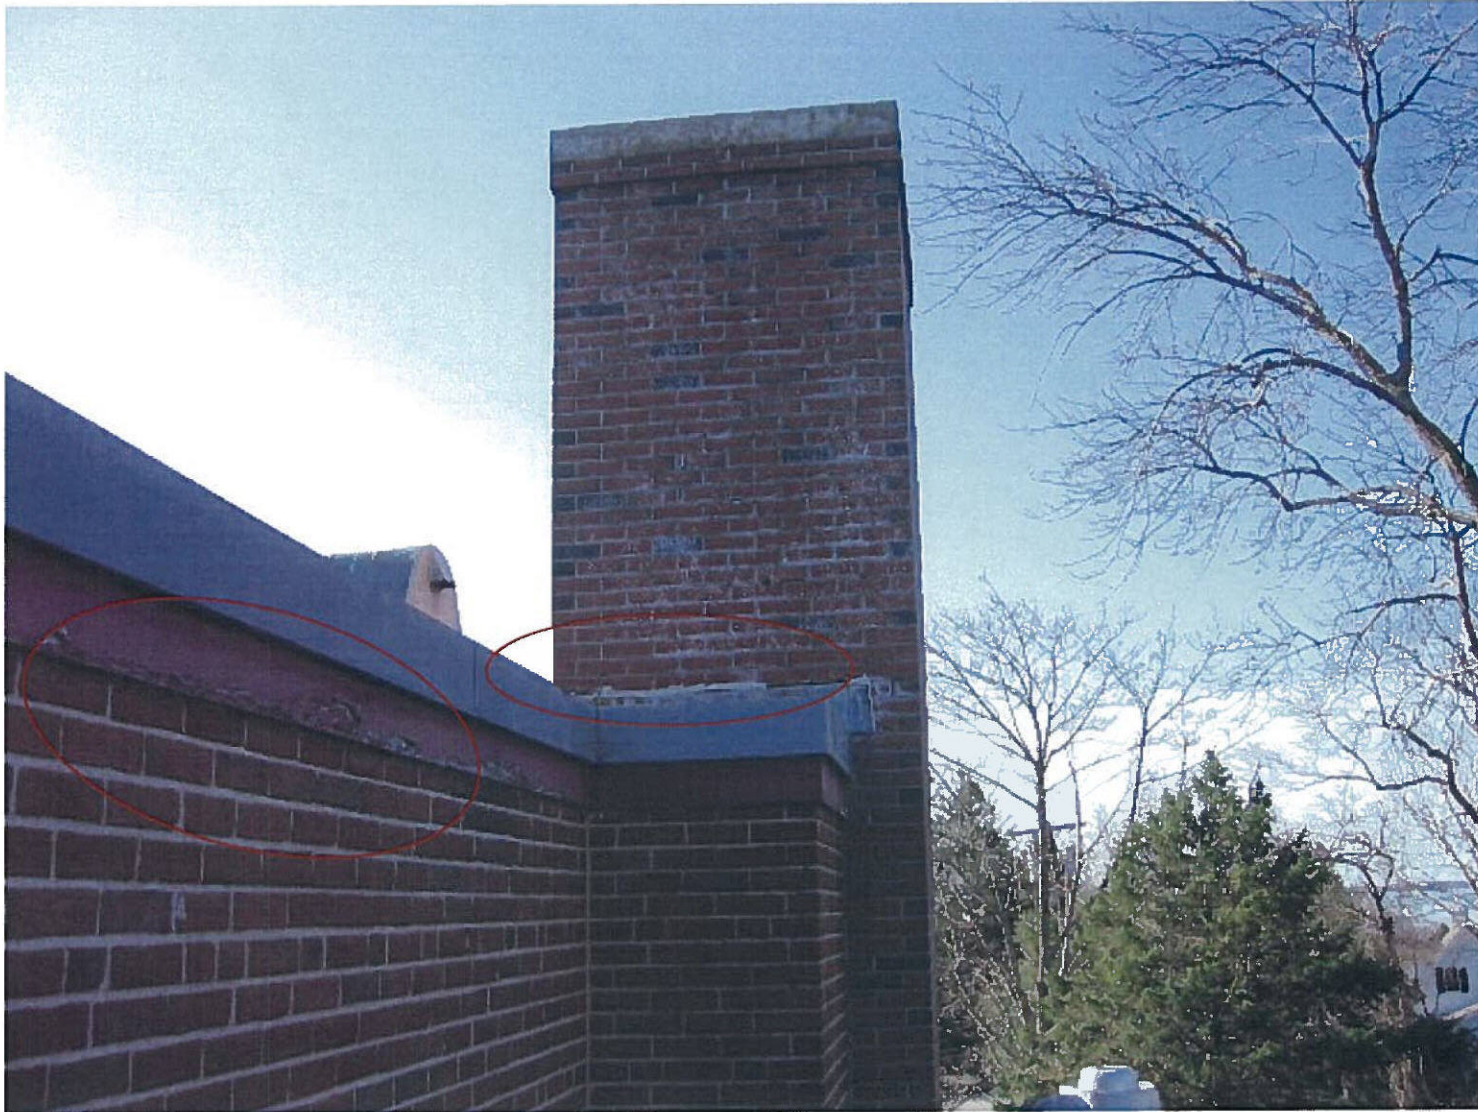
The entire wooden and metal exterior surfaces need painting. The abatement of lead paint may be necessary but it is unknown at this time. There are structural cracks in the brickwork and areas where water has caused structural damage. (See photos on pages 12 - 15 of attached briefing.)

Fascia board needs replacement – failure in brickwork structure

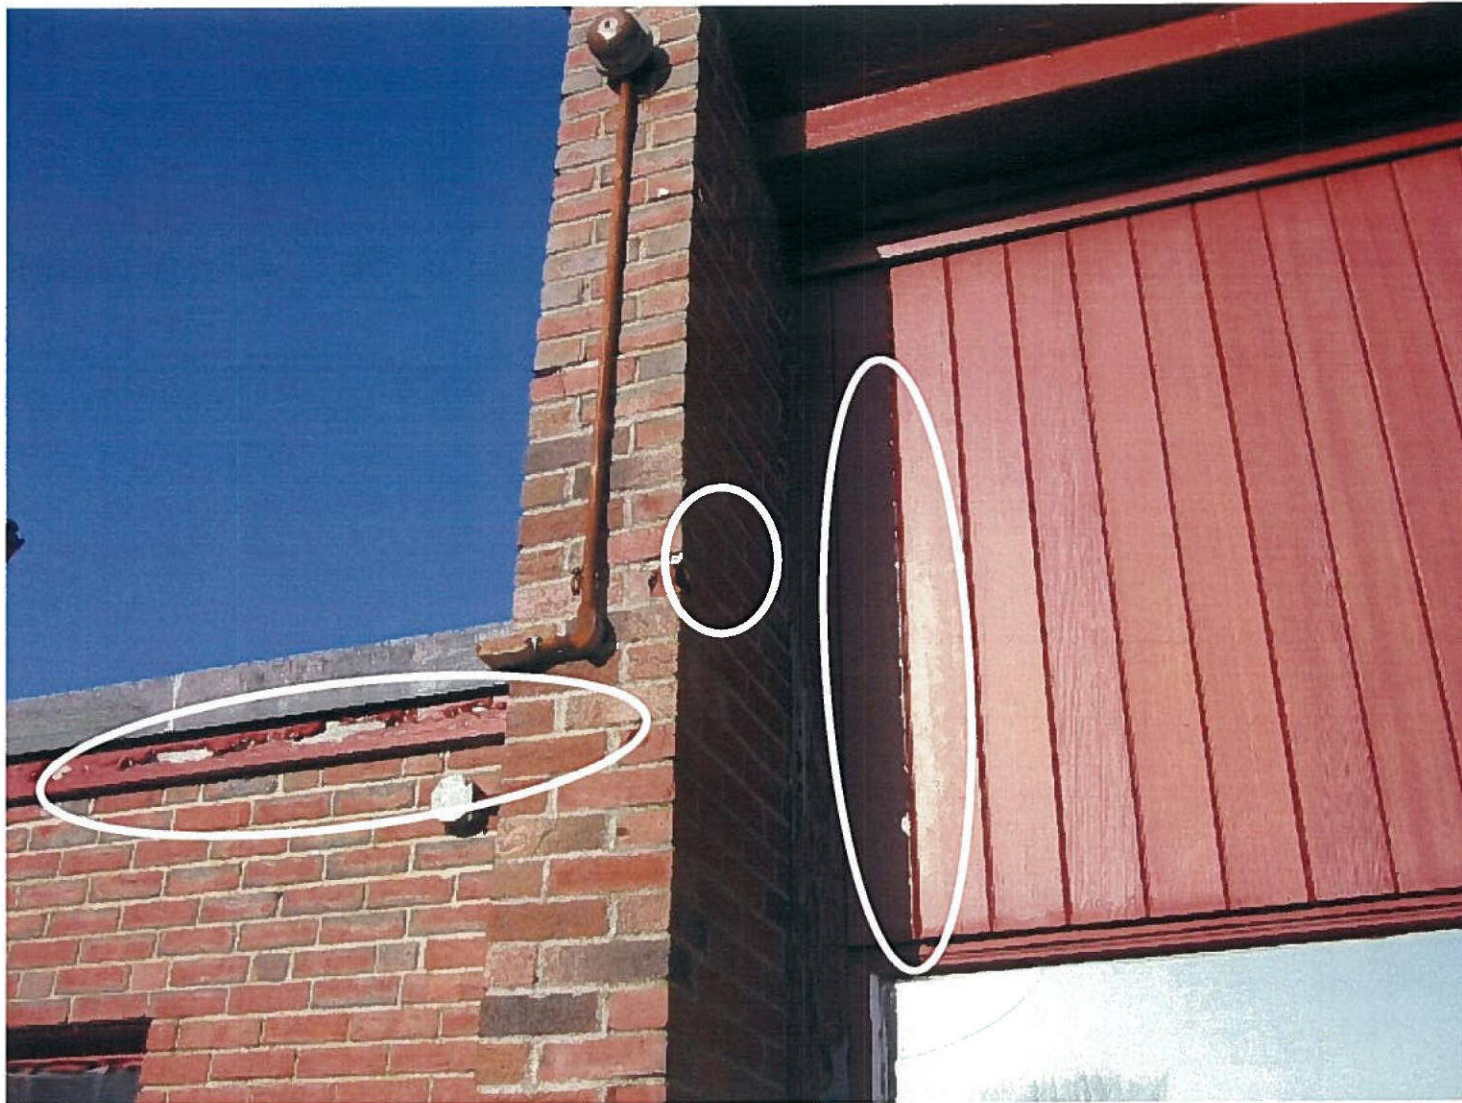
Fascia needs replacing – brick work failing – water damage at joint

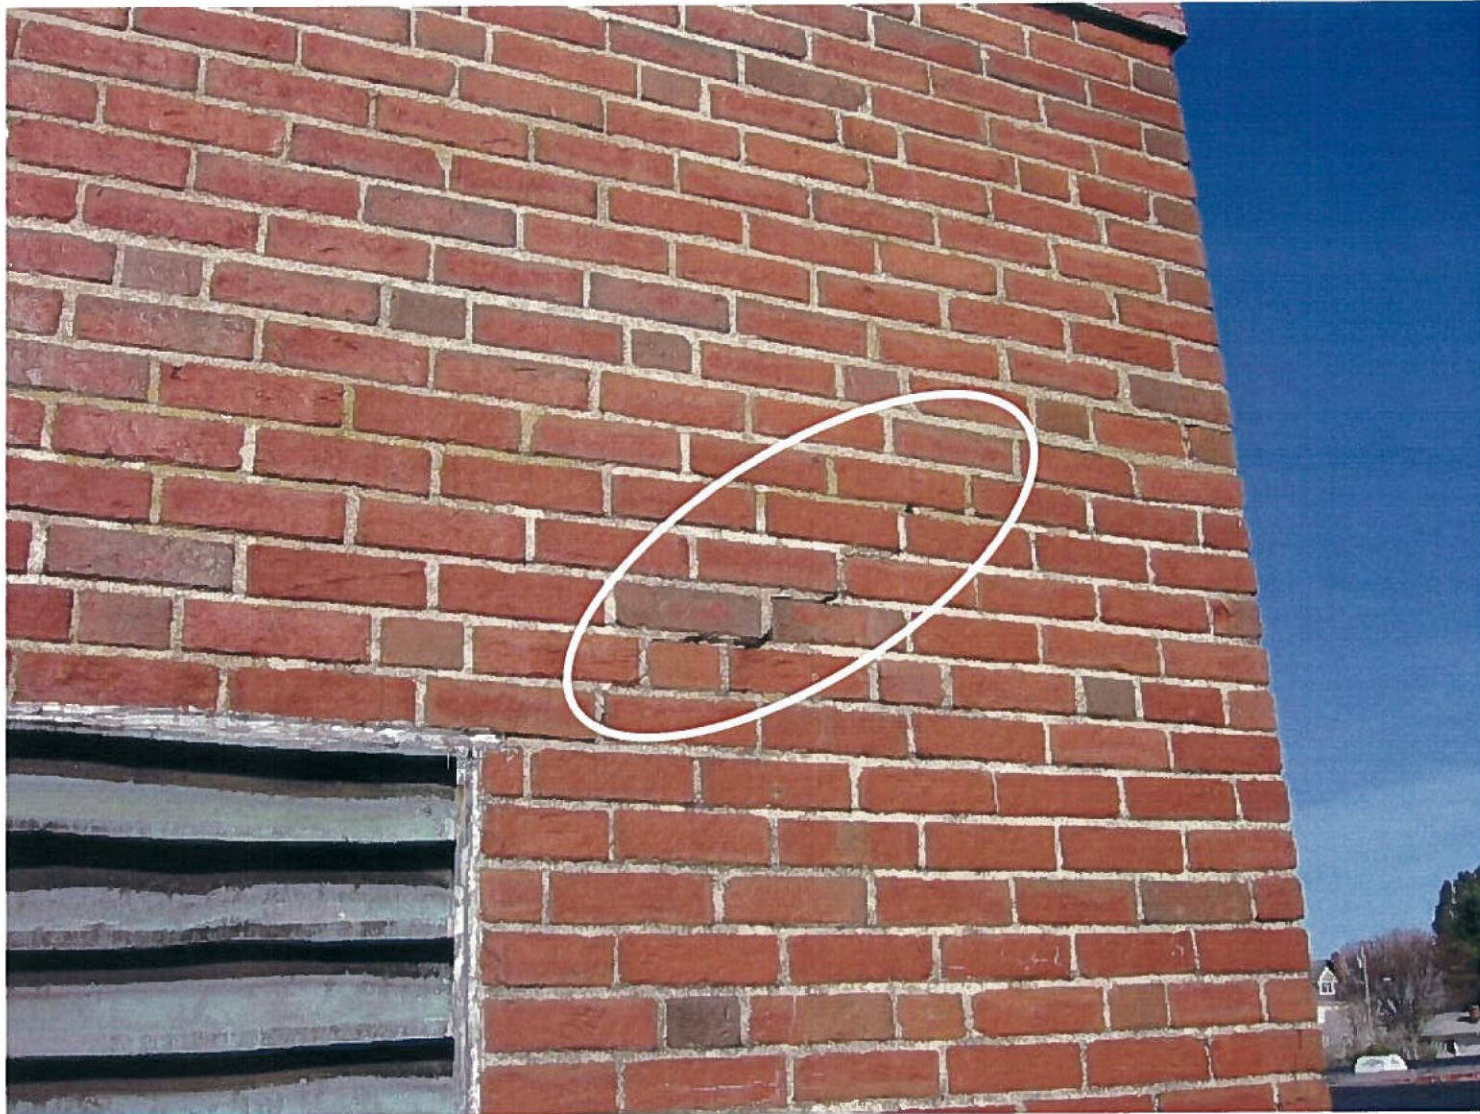
Structural crack in brickwork

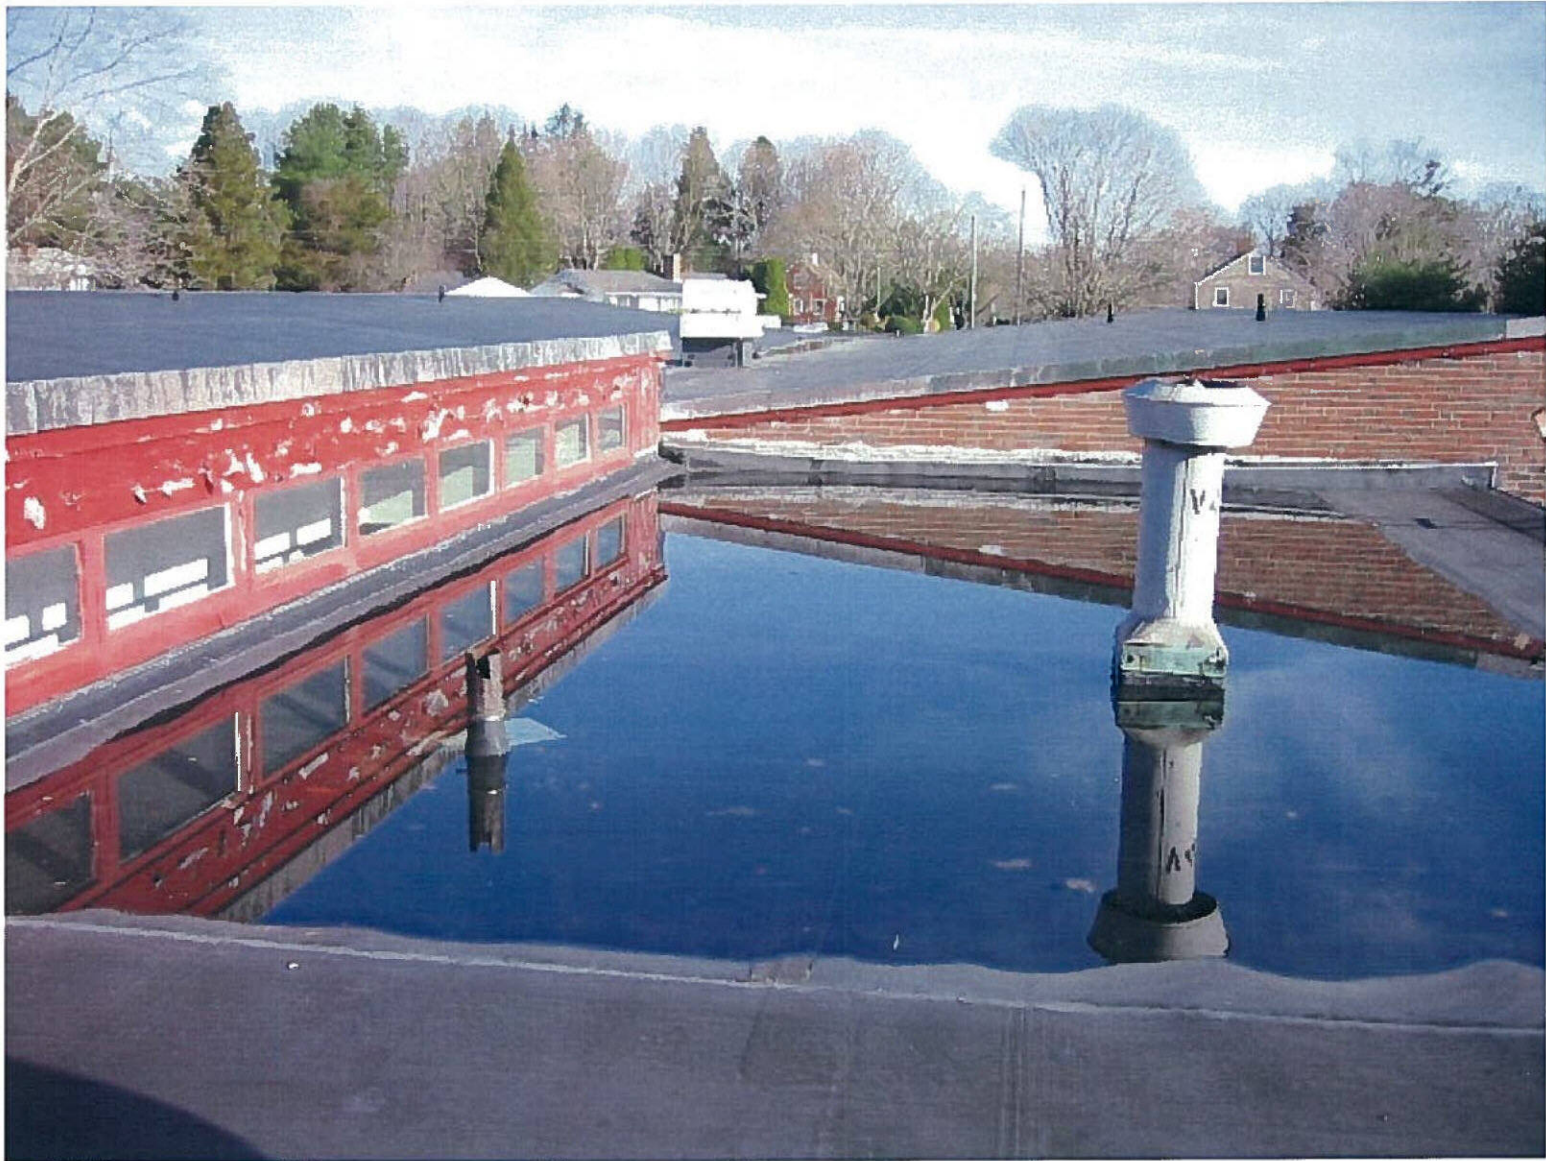
The roof, a mixture of built up and membrane is approximately 28,000 SF and leaks have developed in at least 4 areas, the kitchen, the gymnasium, an office, and the hallway between the gymnasium and the newest addition. The entire roof is in need of replacement; at a minimum there are 4 areas that need extensive patching. One of the issues with these older flat roofs is the inability to add adequate insulation to the roof. It appears that the roof pitches are not in proper alignment and/or the existing drains are plugged. (See photos on pages 16 - 19 of attached briefing.)

Old poorly designed roof with clogged drains - chipping paint – single pane windows
